LITHOSTAR Modularis

Service Instructions SP011/02/I

Title: Fuse F5 of the cooling unit

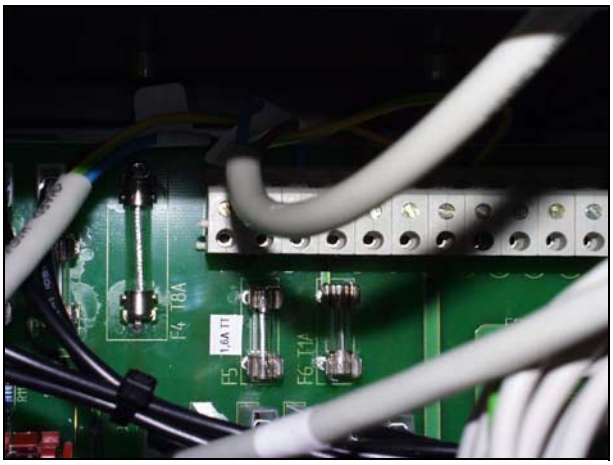
Fig. 1

Depending on the line voltage or the line frequency it can happen that the fuse F5 of the cooling unit on board D1 responds when the system is switched on.

- Switch the system off and pull out power plug.
- Remove the covers.
- Remove defective fuse from board D1.
- Cover the fuse value printed on the board with a new label.
- Insert new 1.6A FTT fuse.
- Reattach covers.
